# Manhole Inspection Summary

Manhole # **S43MM\_005MH**

Insp Date: **3/12/08 12:17 PM**

**Location** Address: **1900 NORTH AVE**

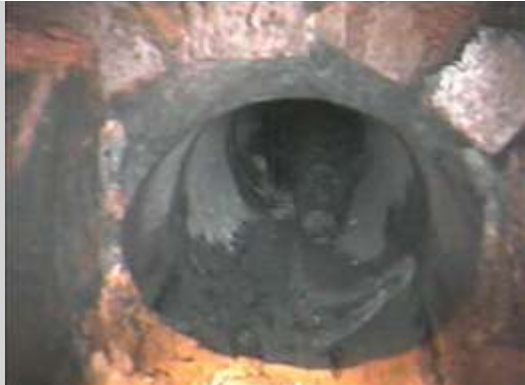
12 O'Clock Outflow

8 in. Circular Gravity Sewer  
Pipe Out @ 12 O'Clock

Pipe Height: (in.) Direct  
Pipe Material: **Clay** ☐ Pipe Lined  
Invert Depth: **9.65** (ft.) Flow Characteristics: **None**  
Deposits: ☒ None ☐ Mud ☐ Sludge ☐ Debris ☐ Grease  
Silt Depth: (in.) Deposits Extent:  
Infiltration: **None** Pipe Seal Cond: **Sound**

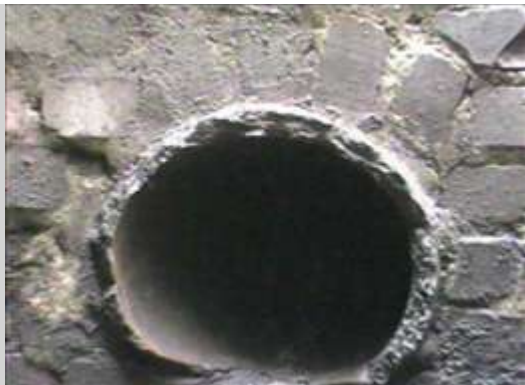
3 O'Clock Inflow

8 in. Circular Gravity Sewer  
Pipe In @ 3 O'Clock

Pipe Height: (in.) Direct  
Pipe Material: **Clay** ☐ Pipe Lined  
Invert Depth: **5.68** (ft.) Flow Characteristics: **None**  
Deposits: ☒ None ☐ Mud ☐ Sludge ☐ Debris ☐ Grease  
Silt Depth: (in.) Deposits Extent:  
Infiltration: **None** Pipe Seal Cond: **Cracked**

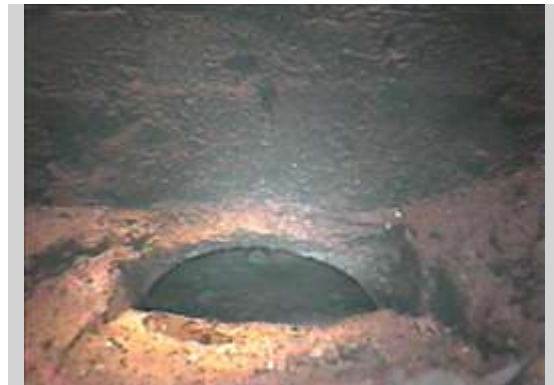
Drop In @ 3 O'Clock

Drop: **Outside Direct**  
Angled: Reading: (ft.)  
Inv Depth: **9.22** (ft.)

Drop Condition: **Open**

Connects To: **Stub connection / abandoned**
